STUDY OF A 20-YEAR OLD PV PLANT (MTBF PROJECT)

A. Realini, E. Burà, N. Cereghetti, D. Chianese, S. Rezzonico
LEEE-TISO, Laboratory of Energy, Ecology and Economy
University of Applied Sciences of Southern Switzerland (SUPSI)
CP 110, CH - 6952 Canobbio
Phone: +41 91 / 935 13 55, Fax: +41 91 / 935 13 49, E-mail: lee@det.supsi.ch

T. Sample and H. Ossenbrink
European Commission, Joint Research Centre, Institute for Environment and Sustainability, Renewable Energies Unit
via E. Fermi, I-21020 Ispra (VA)
Phone: +39 0332 789172, Fax: +39 0332 789268

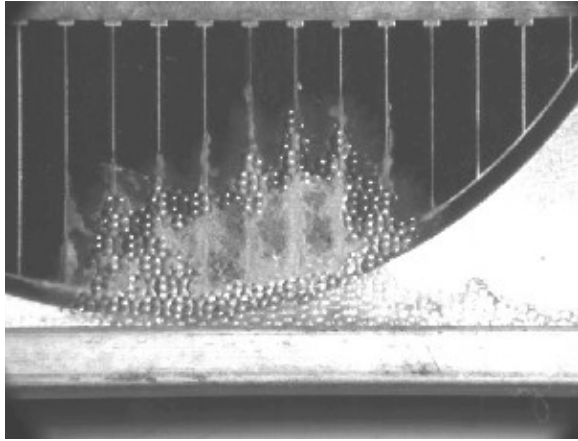
Examination of the installed modules indicated that 92% of the modules exhibited some form of delamination (an increase of 15% in the last four years [4]). In about one third of these panels (27%), the delamination represents a major defect as defined by the International Standard IEC/CEI 61215, as it forms a continuous path between the frame and a part of the circuit (Picture 1).

Picture 1: encapsulant delamination (major defect)

Insulation tests have been performed on both dry and wet (after immersion in water) conditions on the worst delaminated modules. No failure in the insulation was observed, indicating a good level of insulation despite the obvious major defects present.

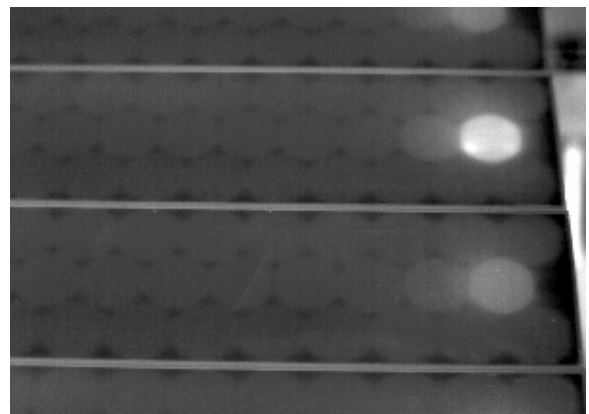
The hot spot cells are likewise always found on the cell in front of the junction box and show an overheating of about 10°C (under real operating condition) with respect to the rest of the module surface, whose temperature distribution is very regular.

An example of a hot-spot cell is given by the module whose IR image is shown in Picture 2 (the hot-spot also corresponds to a delaminated cell).

The IR image of three modules clearly shows two modules exhibiting slightly raised temperatures for the cell in front of the j-box, while the center module exhibits a noticeable hot spot. The current-voltage characteristics of this module are shown in Figure 1, which clearly shows the loss in performance (-24% with respect to the nominal value).

Picture 2: IR image showing the higher cell temperatures and a hot-spot on cell in front of the junction-box ($\Delta T_{\text{cell_module}} \cong 10^\circ\text{C}$).

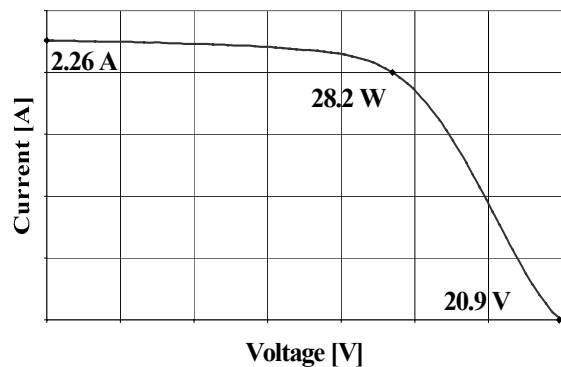
Figure 1: IV curve of the module with a hot-spot (shown in Picture 2).

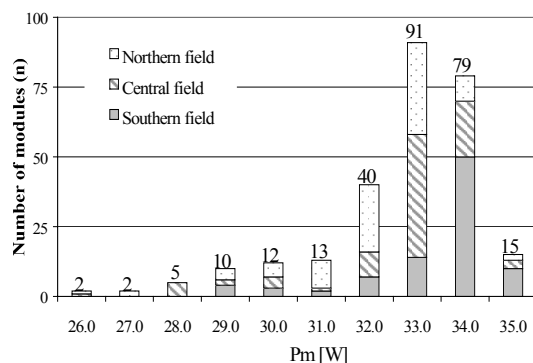
To correlate visual defects with module electrical characteristics and to accurately estimate their power degradation, indoor performance measurements of all of the plant modules were made. Having no initial measured maximum power value for all of the modules, the data have been compared to the manufacturers nominal power (37 W). Results show that, after about twenty years, 59% of the modules exhibited a variation of less than -10% to the stated nominal power, 35% of modules exhibited a variation of between -10% and -20%, and only for the 6% of modules showed a variation loss greater than -20%.

The maximum power distribution of all plant modules (mean maximum power = 33.1 W) is shown in figure 2.

Figure 2: maximum power distribution of all plant modules.

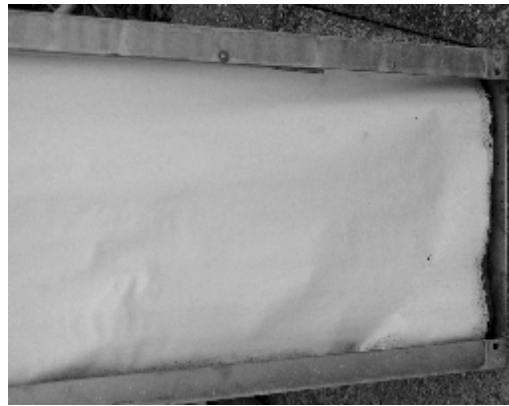
6000 hours of damp heat (85°C and 85% r.h.) provoked very dark yellowing of the module background and tedlar backsheet detachment (see Picture 3). The separation of the backsheet layers, which exposed the aluminium foil, might constitute an electrical safety hazard. However, the electrical power output of the module remained, to all intents and purposes, practically unchanged [5].

Picture 3: tedlar backsheet detachment.

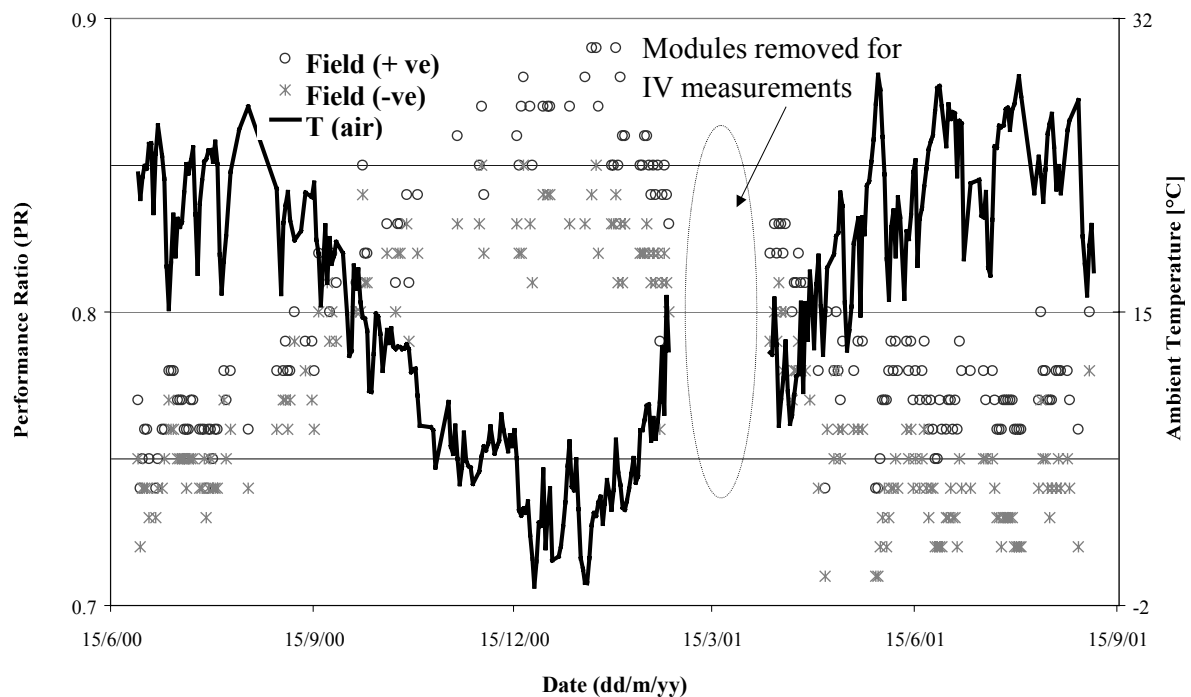
Figure 3, shows the plant Performance Ratio trend, from June 2000 to September 2001 (to simplify the plot, instead of the individual strings, the Performance Ratios of the positive and negative sub-fields are presented).

It should be noted that the lower Performance Ratio of negative field is due to the presence of most of the degraded modules, in particular, there are two panels with hot-spots on heavily delaminated cells.

Also clearly visible in Figure 3 is the seasonal variation of plant energy production, which is strongly influenced by ambient temperature.

Figure 3: Performance Ratio (PR) of positive and negative sub-fields, and temperature trend from June 2000 to September 2001.
